# IFA Technical Conference

# AMMONIA PLANT REFORMED GAS WASTE HEAT BOILER LEAK AND ITS EFFECT ON HIGH TEMPERATURE SHIFT CONVERTER CATALYST

P. Ravichandran and O. Al-Mulhem  
SAFCO, Saudi Arabia

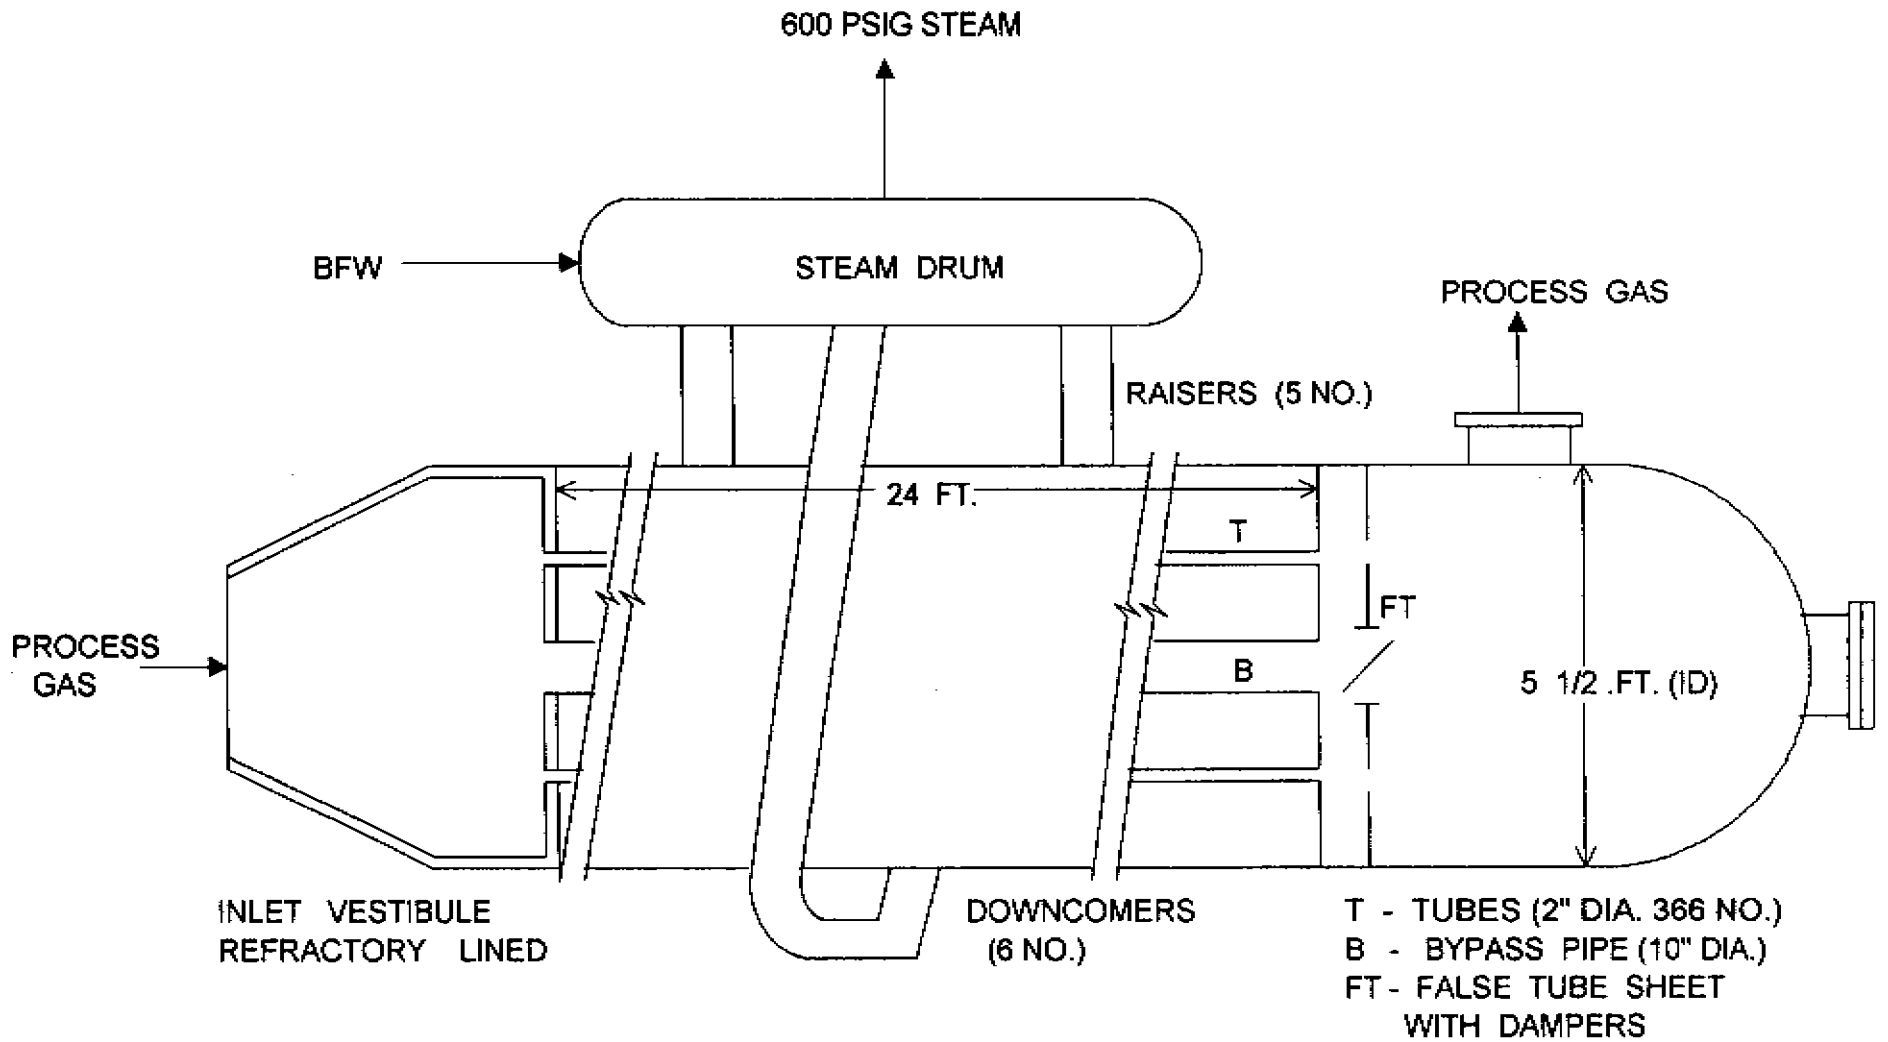
**FIGURE 2. REFORMED GAS WASTE HEAT BOILER**

General configuration of RGWHB is shown in Figure 2. Salient features of the boiler are as follows:

1. RGWHB is a natural circulation, fire tube type boiler producing 136,000 lb/hr of 600 psig steam (gas side pressure is 300 psig).

2. Apart from the main horizontal tubular exchanger, it has steam drum, riser and downcomer pipes, inlet and outlet reformed gas connections, internal reformed gas bypass and false tube sheet with dampers.
3. Reformed gas inlet vestibule is refractory lined CS concentric cone. Internal diameter of CS shell is 66 inch with 24 ft. as face to face distance of tube sheets. Gas outlet chamber is made of C-1/2 Mo steel with 20 inch manway and 20 inch exit nozzle.
4. Exchanger tube bundle has 366 number of 2 inch diameter CS tubes and a CS pipe of 10 inch diameter at the center. The bypass pipe is covered with a SS 310 ferrule. Gap between the pipe and the ferrule is packed with insula-tion material.
5. Close to outlet tube sheet, there is a false tube sheet with dampers. By operating these dampers, gas flow through the bypass pipe can be varied to control gas outlet temperature.

The boiler had two leaking tubes and a circumferential crack in the center bypass pipe near the outlet tube sheet. Nine tubes were having defects like hair line crack at the inner surface, fitting and mechanical damage, erosion and fissures. Totally eleven tubes were plugged and the center bypass pipe crack was ground up to 22 mm depth (pipe thickness 25 mm) and welded. Plant was started back on February 25, 1993.

Leak test carried out in RGWHB indicated the center bypass pipe was leaking badly at the previously repaired place and no tubes were leaking. The cracked weld joint of the bypass pipe was ground to 25 mm depth around and welded. It was decided to replace the boiler in the next available opportunity due to repeated leaks caused by thermal fatigue.

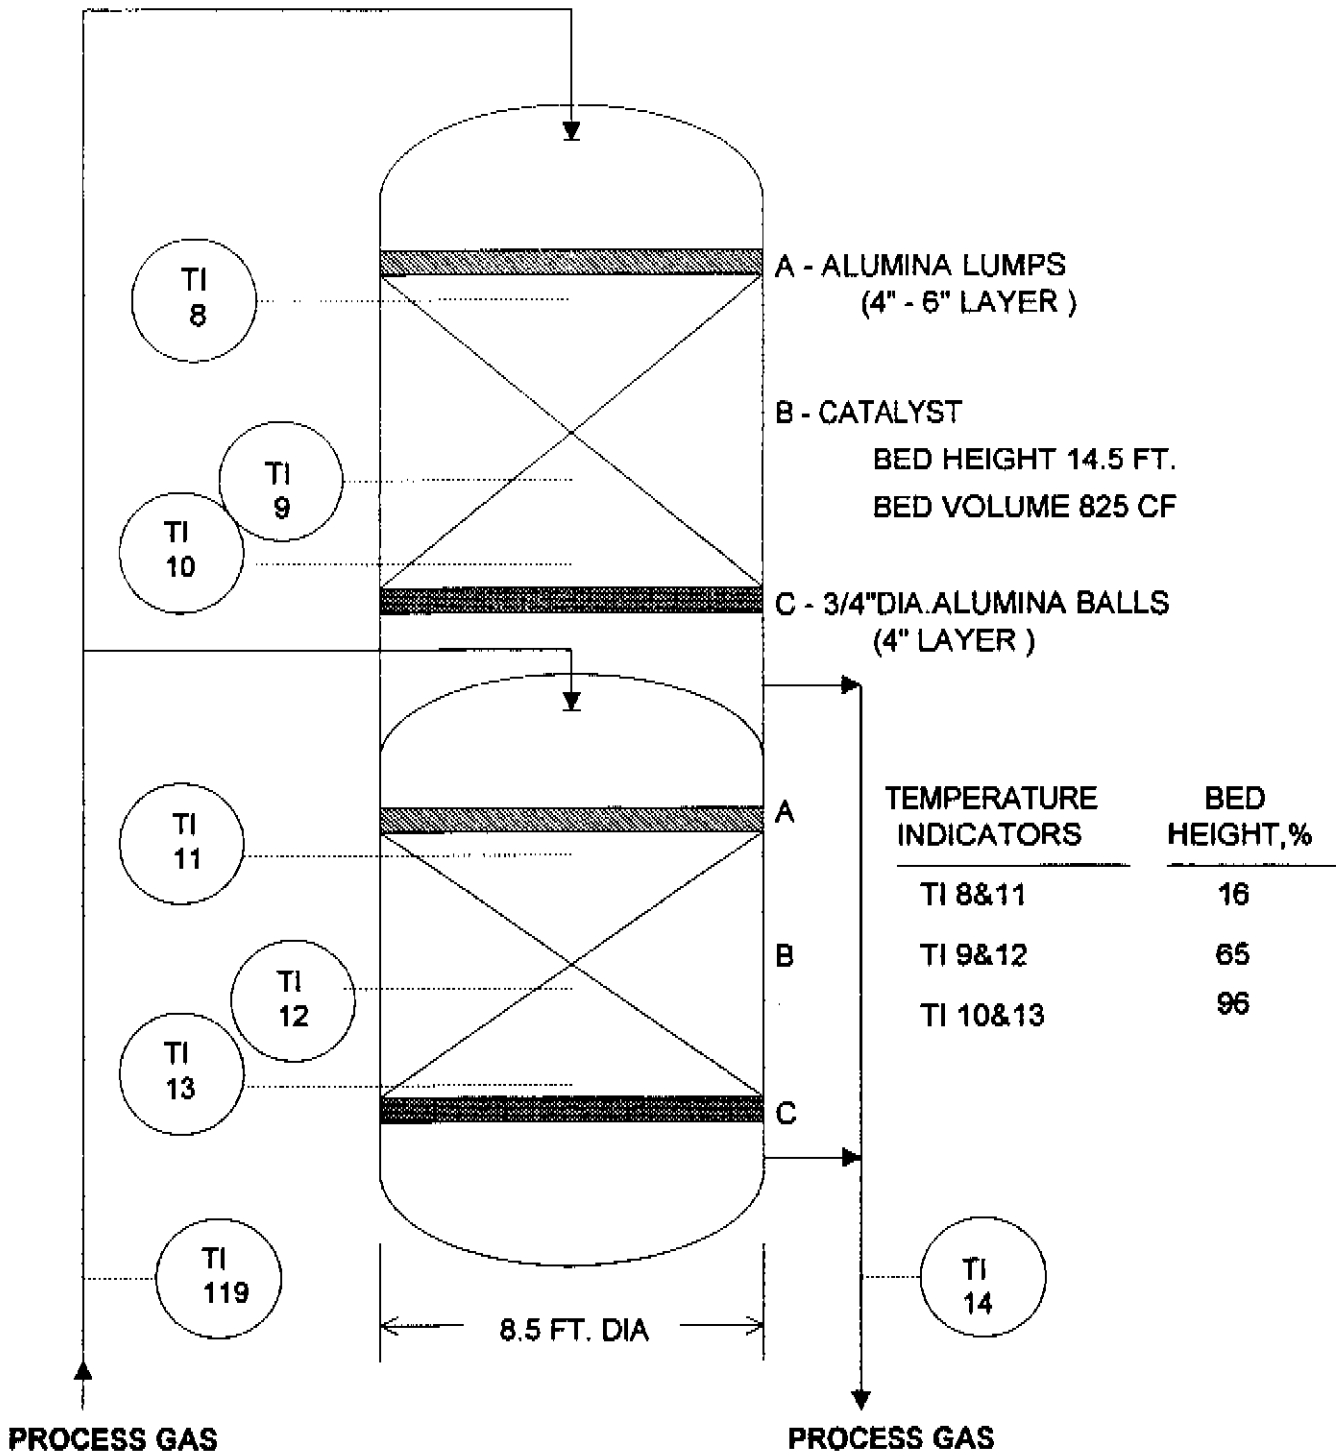
**FIGURE 3. DETAILS OF HIGH TEMPERATURE SHIFT CONVERTER**

This reaction, known as "water-gas shift reaction" is exothermic. HTS converter has two beds in parallel and both beds are installed one over the other in a single vessel (Figure 3). HTS converter was charged with chromia ( $\text{Cr}_2\text{O}_3$  - 9%) supported iron ( $\text{Fe}_2\text{O}_3$  - 89%) based catalyst in May 1992. Total catalyst volume is 1650 CF. HTS inlet temperature was maintained at 675°F.

- b. Accumulation of boiler water solids, due to vapourization of liquid droplets on catalyst surface.
3. More amount of water droplets could enter the top bed because of the configuration of gas inlet line to both beds. The vertical gas inlet pipe runs up to the top bed with a tee-off connection to supply gas for bottom bed. Due to inertia, most of the liquid droplets would travel straight to the top bed. This could be the reason for more restriction in gas flow through the top bed.

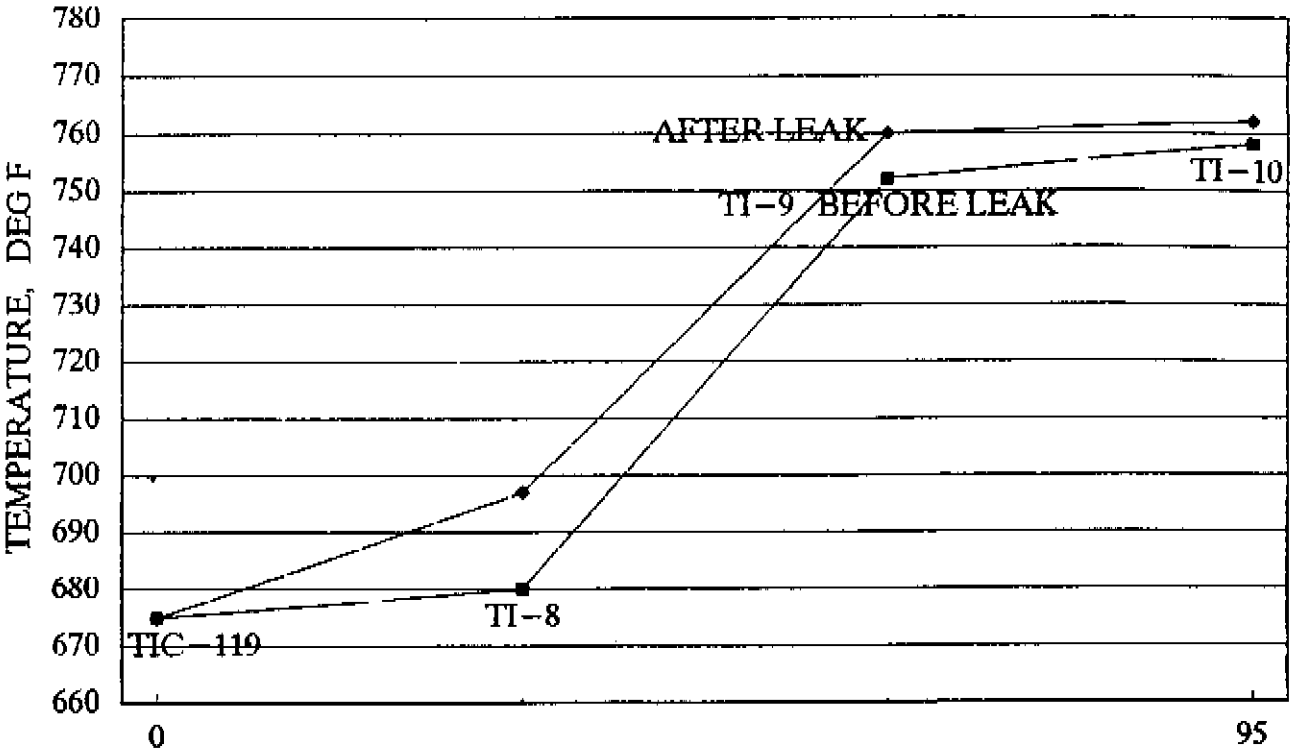
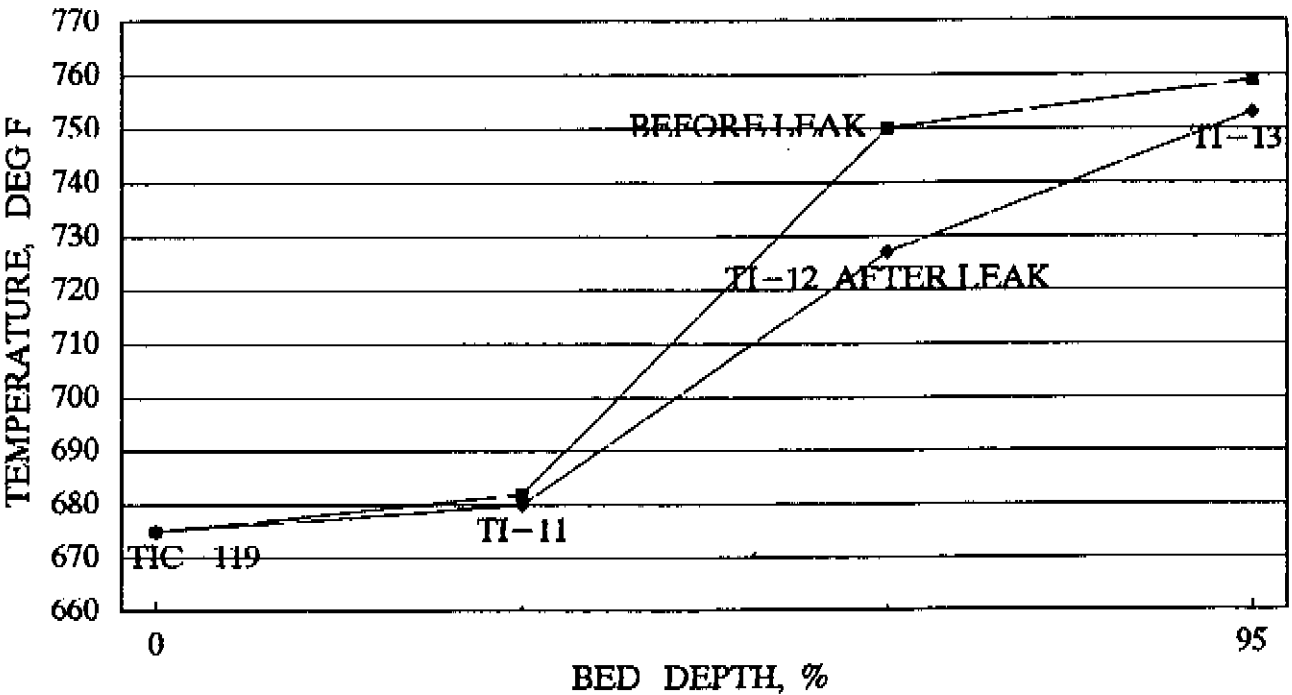
**FIGURE 4. HTS BED TEMPERATURE PROFILES**

Three temperature indicators are available in each bed at bed depths 16%, 66% and 95%. Inlet and outlet temperature indication points are common for both beds. Temperature profiles before and after occurrence of the leak in RGWHB are shown in Figure 4. After the leak, temperature profiles of both beds changed significantly. Temperature at 95% bed depth of bottom bed (close to outlet) was 10°F less than that of top bed.

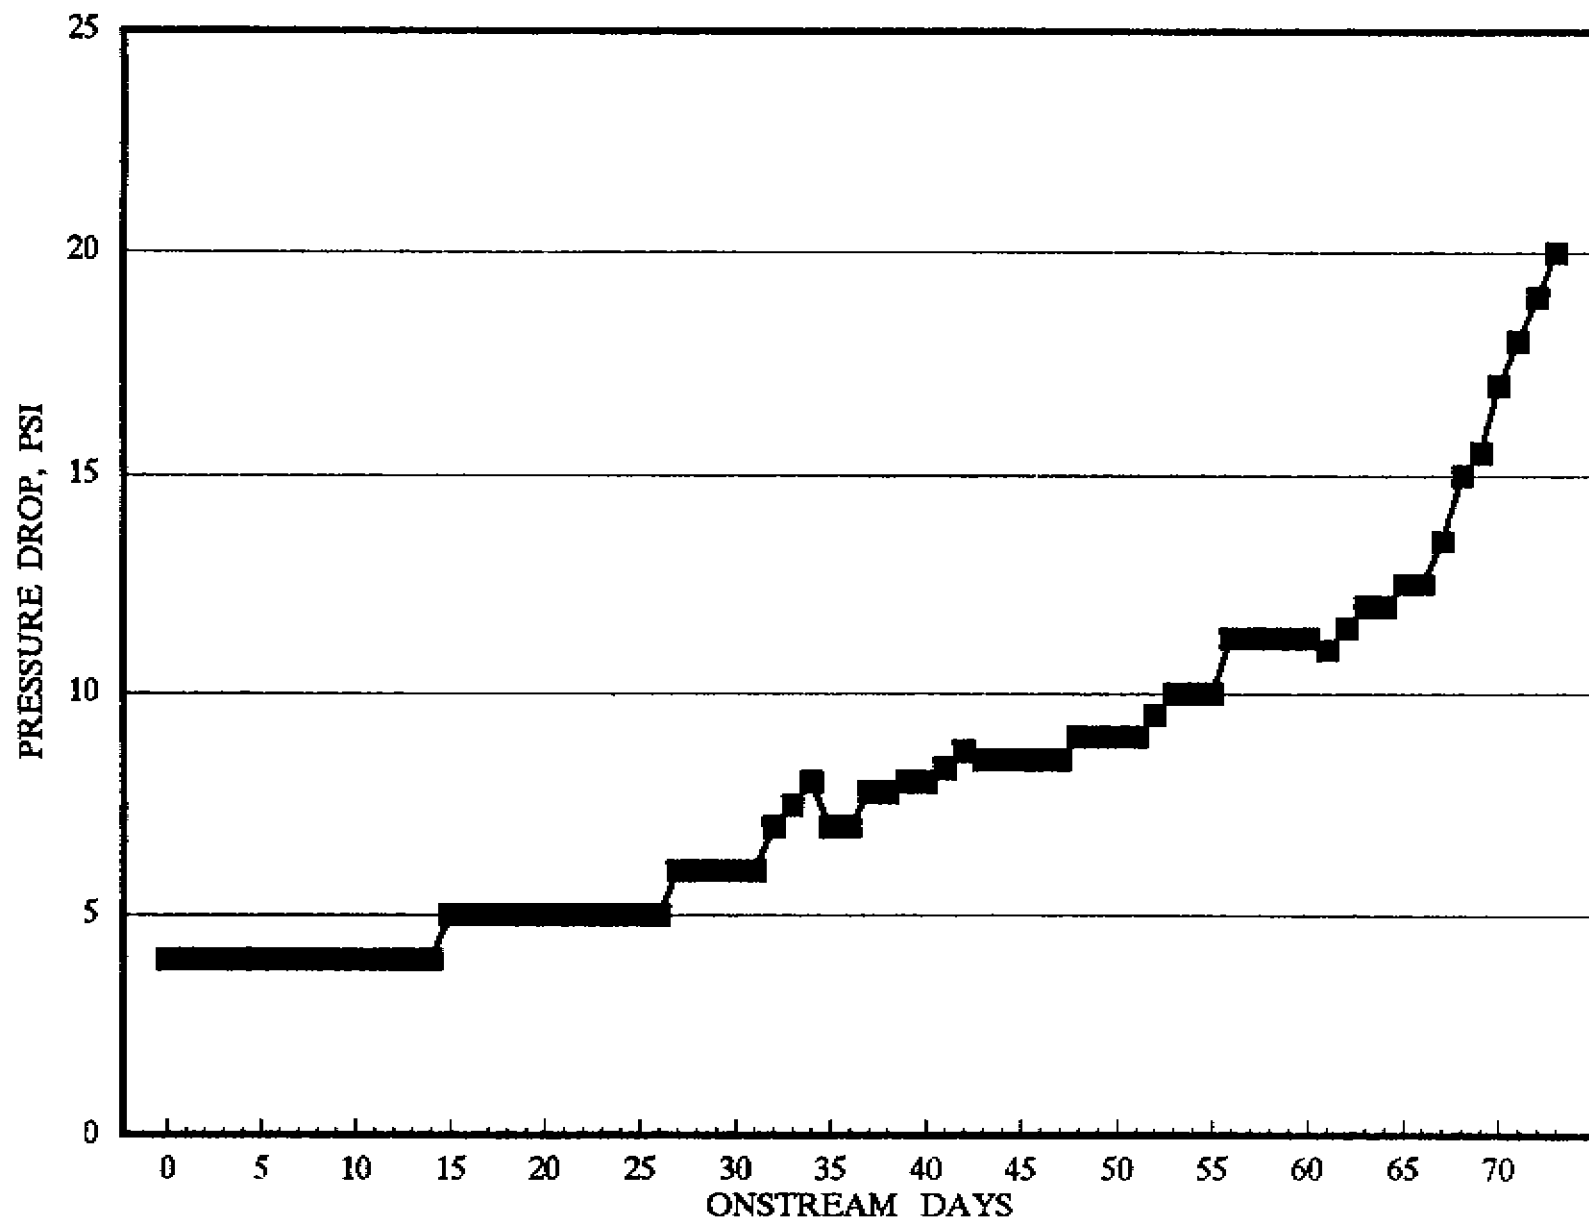
FIGURE 5. INCREASE IN PRESSURE DROP ACROSS HTS CONVERTER DUE TO BOILER LEAK

Pressure drop across HTS was 4 psi since charging of catalyst in May 1992. After the boiler leak, pressure drop gradually increased to 20 psi as shown in Figure 5. Earlier, maximum pressure drop experienced in this vessel was 8 psi with previous catalyst charge of same type, after 8 years of onstream life.

2. Increase in pressure drop might have been due to either or both of the following factors:
  - a. Disintegration of top layer catalyst particles due to droplets of liquid water entering from RGWHB leak and vaporizing on catalyst surface.
